DAMAGE IN HISTORIC RAMMED EARTH STRUCTURES: A CASE STUDY AT AMBEL, ZARAGOZA, SPAIN

Theme 2: Heritage and conservation

Key words: rammed earth, building failure, unsaturated soil

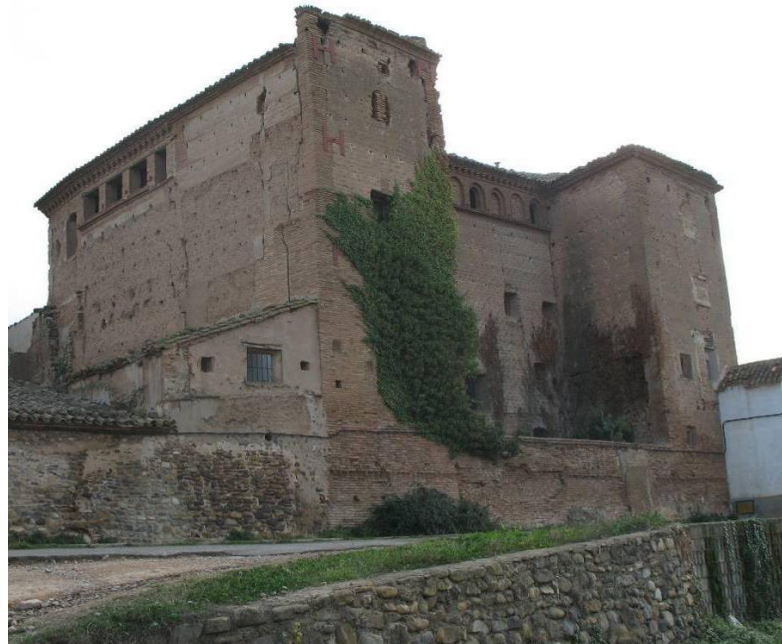
Figure 1) – two slightly inclined cracks in the centre of the building; and two vertical cracks at the north end of the east elevation, which are related to the lean of the north gable end wall. This wall leans outwards from ground level to mid-height of the second storey, with the section above this being built vertically on top of a leaning wall. The current owners of the building installed crack monitoring points in the early 1990s and this monitoring shows the continued opening of the cracks at the northern end of the tower. As a result, tie bars were placed at ceiling level at the ground, first and second storeys in 2000. These are fixed internally by bolting onto the ceiling beams and protrude externally to link to H-shaped bars on the facade which were positioned so as to overlap the brick quoins (Figure 1).

Figure 1 The preceptory at Ambel, north-east elevation. The gallery of arches between the towers is typical of 16th century architecture in this region. The first phase precinct wall reaches the base of ivy and stands 3m high.

One feature of medieval Spanish architecture is the use of rammed earth fill *between* fired brick columns (Jaquin 2008a). Inspection of a number of such joints between the brick and the rammed earth shows that there is no structural tie between the between the two. Any structural movement therefore results in an opening of the joint. This is particularly a problem in later medieval architecture, where brick quoins are used, and structural movement (for example of the gable end of a structure) is unrestrained and leads to an opening of the joint. An example of this can be seen on Figure 1 immediately below the eaves at the northern end of the tower.

Where water has been allowed to gather and run down the face of a wall, cast structures, such as described in Section 4.1, are observed on the face of the wall (Figure 5). However, these have served as a forewarning of further damage and caused the building owners to undertake repairs. As a result, there are no deep incisions into the rammed earth as shown in Figure 4, and as observed at other historic rammed earth sites (Jaquin 2008b). However, the eaves do not protrude on any of the faces, and this may have allowed a water flow down the face of the wall. If water is allowed to gather behind the render, then the rammed earth may become locally saturated, meaning the liquid bridges providing a bond between the render coat and the rammed earth may become saturated, causing the render to spall away from the wall (Figure 1).

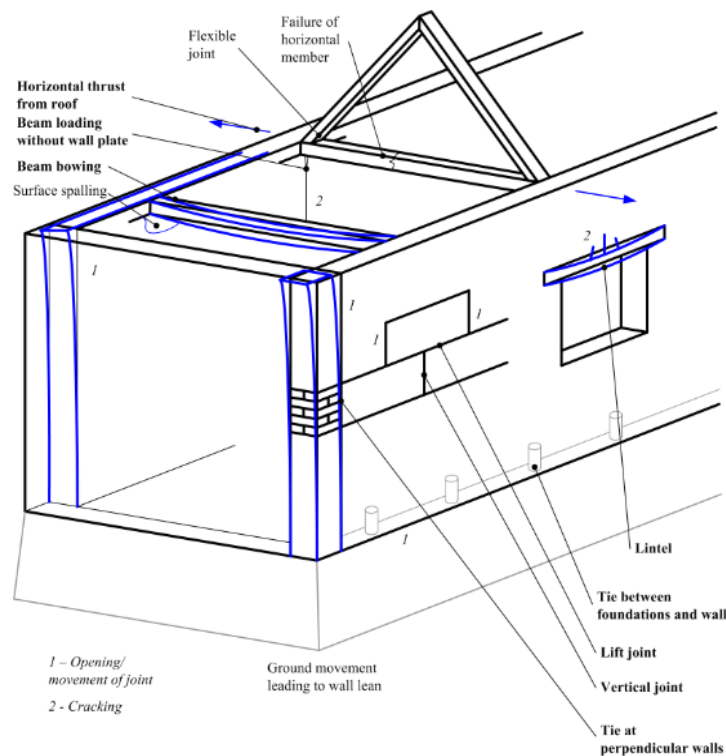
There are a wide range of causes of structural problems, including ground movement, failure or inadequacy of building elements, incorrect design, or excessive loading. This paper focuses on those issues which are felt to be specific to rammed earth. Figure 2 shows some of the mechanisms which have been identified. Potential causes of structural problems are shown in bold, while their effects are shown in a normal font. The numbers 1 and 2 in italics refer to positions where opening or cracking may occur. Three particular issues with rammed earth in

To prevent localised shear failure of the wall beneath a load bearing transverse beam, wall plates are used to spread the load over a larger area. Where such wall plates are absent, either through poor initial design or later alteration to the structure, there is the potential for shear failure of the wall beneath the loaded beam. Out of plane failure can also occur where a beam joining a wall is insufficiently stiff and bows under loading. This causes an increased load at the face of the wall, and can lead to spalling of the material at the face (Figure 2).

Figure 2 Examples of failures of structural elements

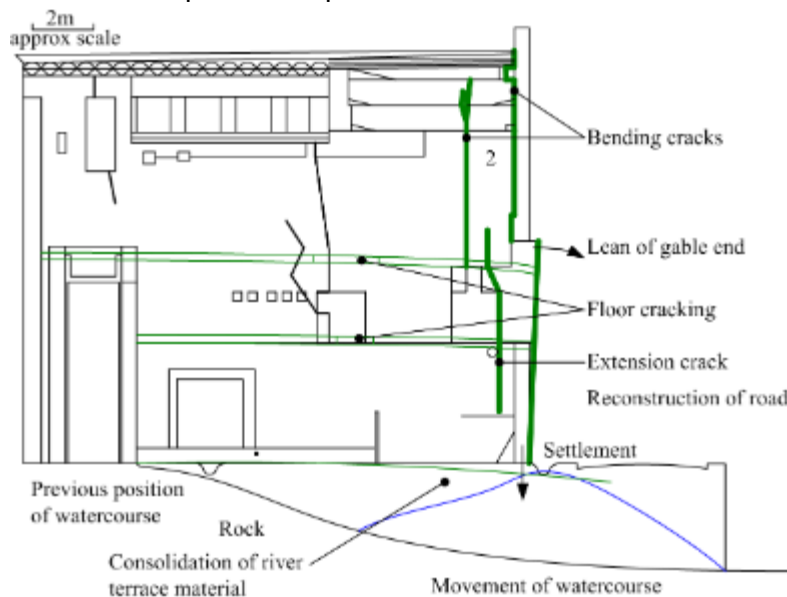
The gable end wall of the north-east granary at Ambel is showing a significant outward lean at the head of the wall, and monitoring of the cracking patterns shows that the cracks continue to open. The cause of this lean is assumed to be an ineffective retaining wall to the north of the gable wall, allowing continued settlement of the ground. The nature of the foundations of the tower is not known. As it is not currently possible to reinstate this wall, or to upgrade the road, hard intervention techniques have been used.

Reinstatement of the roof of the granaries occurred around the same time as the late 18th century repairs. At one location this involved the introduction of a transverse timber beam which carries a large proportion of the roof loading into the south gable end wall. This timber is causing in-plane cracking of the rammed earth wall because of the lack of a wall plate.

Figure 3 Cracking patterns and causes, east-facing elevation of the north-east tower at Ambel

In the late 18th century a number of *hard* repair measures were already being enacted at to prevent collapse of the leaning north wall. There is no structural tie between the rammed earth north and east walls, and the brick quoin at the corners. As described above, a further storey tower may have existed at the north of the granary, and this tower may have provided a structural tie between the gable end and the transverse walls. Analysis of the architectural fabric suggests that timber buttressing was placed against the external wall, and repairs were carried out to the ceiling arches at each floor. In addition, battens were embedded at the north end of the east and west walls, spanning to the leaning north wall. Their effectiveness is questionable, as cracks are present in the wall at the south end of these timbers. This indicates that the timbers may have succeeded in stiffening the north end of the structure, but because ground movement has not been halted, further deformation and cracking has occurred. In 2000 H-shaped spreader plates were fixed to the face of the wall, which are affixed to 150mm x 80mm I-beam sections running through the length of the building. These I-sections are bolted to the transverse ceiling timbers at each side of the building at ground, first and second floor levels.

Although this intervention follows sensible principles, it may be noted that the horizontal component of the lean of the gable wall is transferred directly to the transverse timbers through bolting, which maybe prove unsatisfactory, with the bolts shearing from the timber with increased horizontal load from the gable wall. Monitoring of crack growth shows that the placement of this system has not arrested the growth of the cracks, suggesting that it is yet to engage or is proving ineffective. Future work is now being suggested which will involve the placement of spreader plates on the outside of the south wall, allowing the I-beam sections to span the whole length of the building and thereby stiffen the whole structure.

Where the cause of the structural problem has been mitigated, then a *soft* repair of filling of the cracks is recommended. This will not only improve the appearance of the building but also prevent water ingress. At Ambel, cracks in the centre of the long east wall are thought to have formed prior to the movement of the gable end, and have therefore been filled. The filler is brick, which would originally have matched the scored rendered original face of the rammed earth,

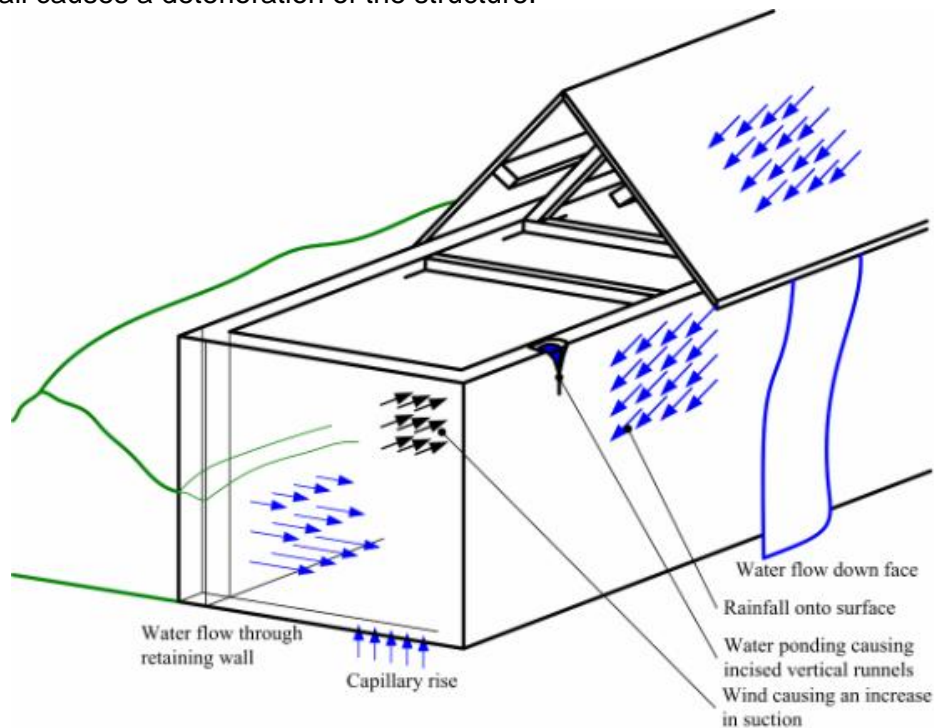
Water *does* pose a problem for unstabilised rammed earth structures where it is allowed to flow down the surface of a wall. This usually happens where it is allowed to gather (pond) at the head of a wall, and flow down the face. Because of the larger volumes of water involved, the rate of water infiltration overtakes the rate at which water is removed from the wall by evaporation, and so a drip forms on the surface of the wall. This may allow the surface of the rammed earth to become saturated, and for soil particles to become suspended within the liquid and flow. This mechanism can be seen in the formation of worm cast type structures where material has first flowed into a slurry, then dried to leave mounds of fine material on the wall face. The presence of these structures indicates the downward movement of material and is thus indicative of past water flow. The likely cause of the formation of the structures is the slow downward movement of water down the face of a wall, for example a drip which is able to pick up material and transport it in solution down the wall, until such a point as the drip evaporates and the material is returned to the wall. Inspection of these structures indicates that they contain only very small particles, as it is only these which may be picked up by the water. The rate of infiltration of water into the body of the wall is sufficiently slow that the drip of water is able to continue down the face of the wall, saturating and therefore picking up smaller soil particles, before all the water is absorbed by capillary action into the wall and those smaller soil particles redeposited. If the rate of water flow is increased, such as by an ineffective drain, then larger soil particles and larger volumes of material are picked up by the water flow, and incisions form

in the vertical face of the wall (Figure 4). This mechanism involves the movement of material down the wall causes a deterioration of the structure.

Figure 4 Causes of damage by water

Repair of rammed earth walls damaged by water should only be attempted when the cause of the water flow has been addressed. It has been argued that the main repair strategy for water damage is reinstatement of the head of the wall to prevent further water flow down the face. This has taken the form of concrete ring beams for the restoration of the towers at Biar and La Rambla (Jaquin 2008a) or as bamboo matting at Ait Ben Haddou in Morocco. If it is possible, then the roof of the structure must be reinstated, and the drainage from this correctly positioned.

Repair of the face of a wall, where damaged by water, should involve reinstatement with the fallen or similar material which will provide similar material properties (stiffness, permeability and shrinkage) as the rest of the wall. There are many examples of the repair of rammed earth buildings using a less permeable render such as cement (see Jaquin 2008b). While this render reduces the flow of water *into* the wall, it also reduces the flow of water *out* of the wall. If water is able to enter the wall by any other means (for example through capillary rise), and is *not* able to escape (water only flows upwards by capillary rise), then there is an increase in water content of the wall. This leads to a loss of strength and stiffness, and the wall will fail, either through a the build up of water behind a less permeable render, or by becoming saturated and losing strength and stiffness.

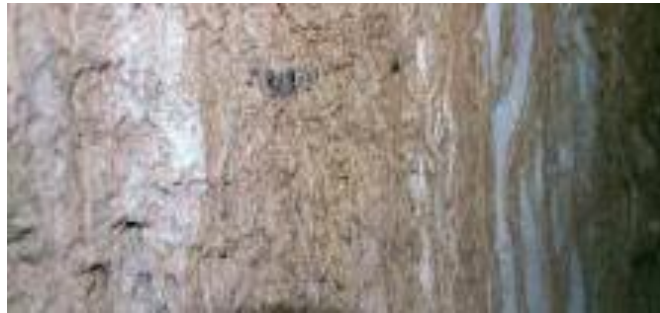
Figure 5 Worm cast type structures visible at Ambel beneath a previously damaged roof section
